Flight Motor Set 360T010 (STS-31R) Final Report

Volume I—System Overview October 1990

Thiokol CORPORATION

**Flight Motor Set 360T010
(STS-31R) Final Report
Volume I-System Overview**

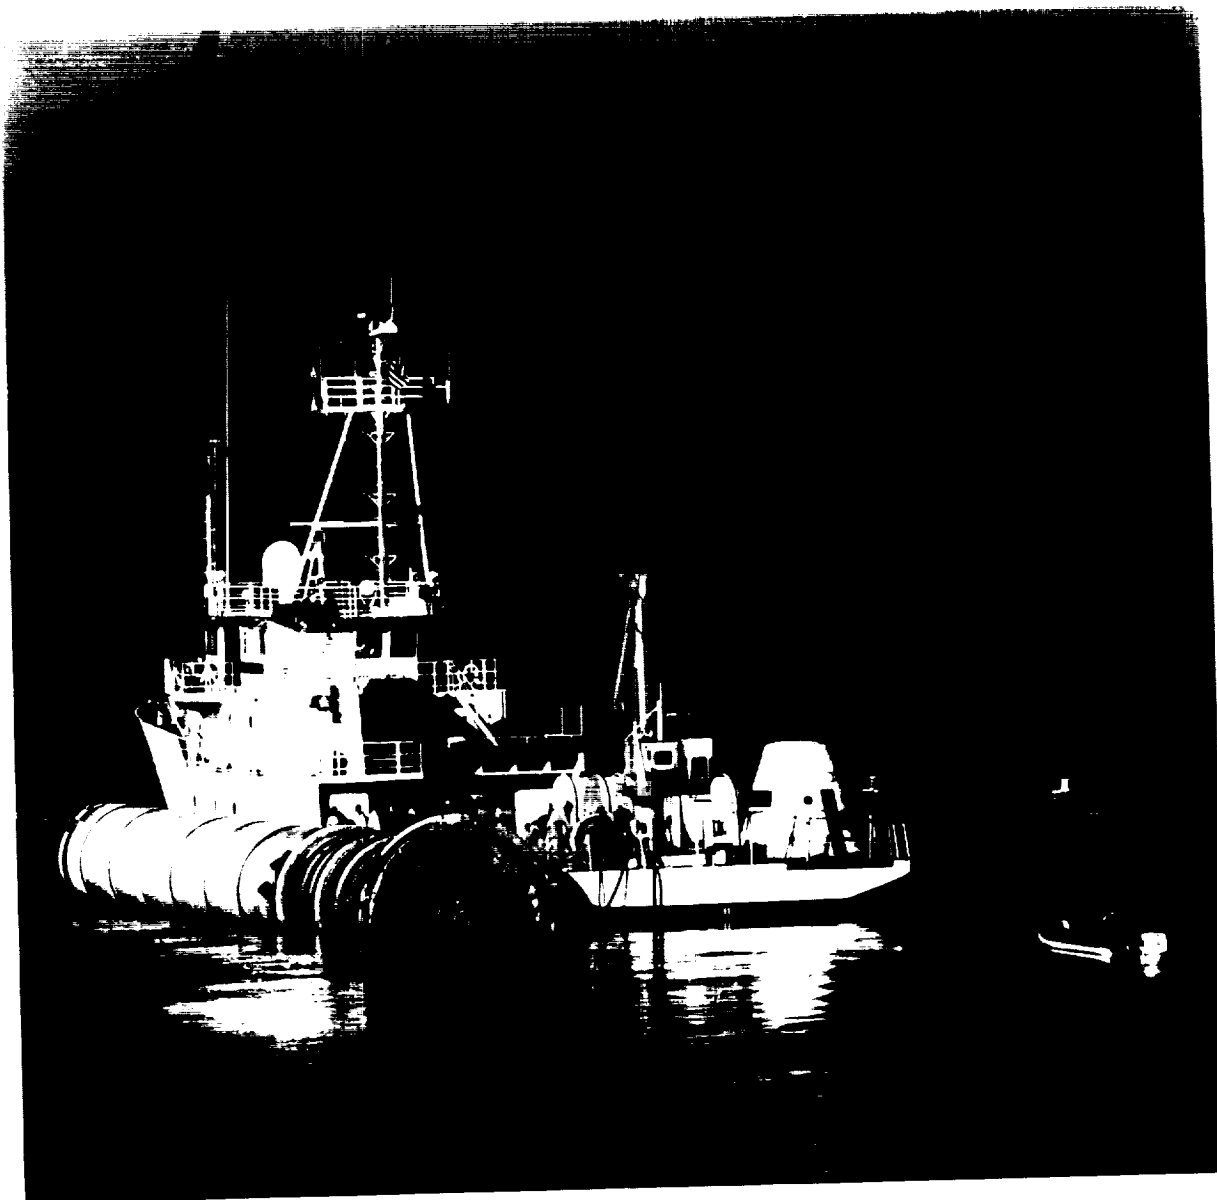
The left redesigned solid rocket motor from flight set 360T010 is towed to Hangar AF for disassembly and evaluation. The motor set performed flawlessly as part of STS-31R, launched 24 April 1990 at Kennedy Space Center, Florida.

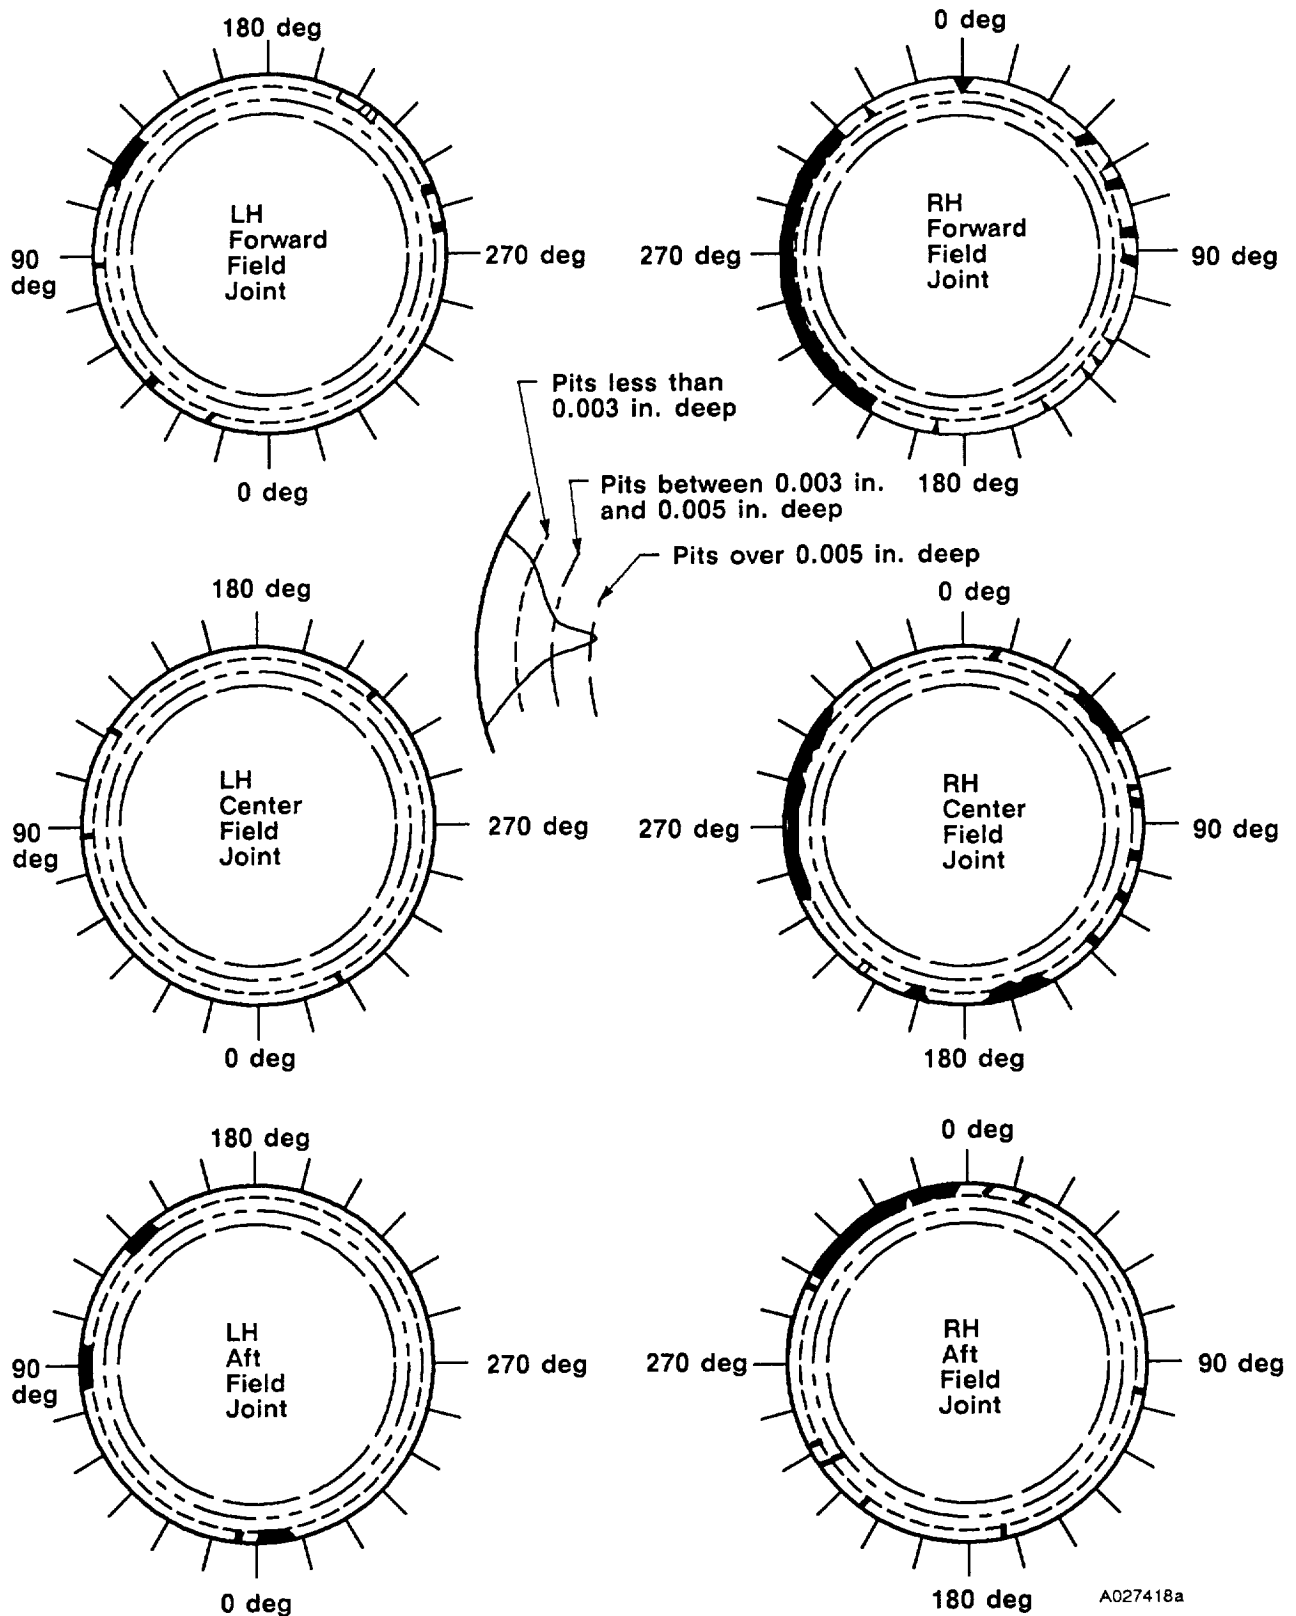
Figure 4.11-1. Field Joint Fretting-360T010

3.1.9.2 Case. The case field joint surface conditions were as expected. Field joint fretting on this flight ranged from light to medium. All joints had some fretting. The RH aft field joint had the worst fretting with one pit 0.005 in. deep. The RH forward, center, and aft field joints had previously fretted segments. There were no new frets found in the old fret indications. Light corrosion was noted on the LH and RH forward dome boss along the outer edge chamfer the full circumference.

On the LH motor case, pits measuring 0.005 and 0.007 in. were observed. On the RH motor, pits measuring 0.005, 0.007, and 0.012 in. were observed. Some of the case surfaces under the removed GEI runs had light corrosion.

A problem has been observed in approximately 50 percent of the field joint tangs following shipment to KSC. Fretted surfaces on the field joint tang outer diameter of the center and forward segments have occurred. The degradation which occurs to the hardware creates no structural problems but requires additional surface preparation following shipment. Various approaches have been investigated to eliminate metal-to-metal contact between the handling rings and tang outer diameter. Laboratory testing has been completed to investigate grease additives in addition to sacrificial layers that will eliminate fretting. Grease additives and coatings have proven unsuccessful. Sacrificial layers such as molydisulfide nylon and polymeric reinforced Teflon have stopped fretting in the laboratory. Engineering is currently in the process of adding test samples of these two materials in an actual shipment to KSC. Implementation of these test materials should take place on Flight 19.
